Northern Rakhine State – damage assessment map and sample satellite imagery

1. The map shows areas with visible destruction, through burning, of houses, other structures and vegetation in the three northern Townships (Maungdaw, Buthidaung and Rathedaung) of Rakhine State. The map was developed through the analysis of high-resolution satellite imagery collected on multiple dates between 25 August 2017 and 18 March 2018. Destruction is represented by coloured dots, with colours corresponding to the date range when visible destruction was detected. Due to cloud cover and satellite overpass range, damage is detected within a date range. The date range refers to damage detection, as opposed to when it actually occurred.

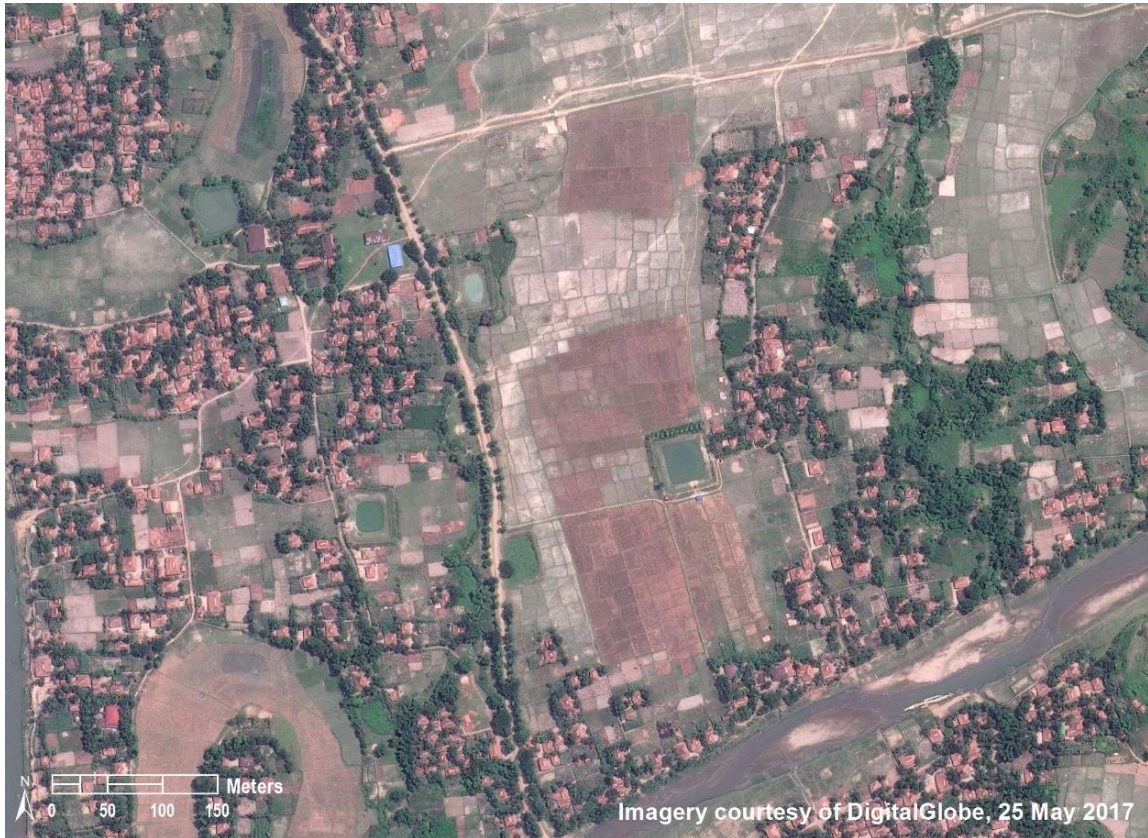
IMAGE 1: 25 May 2017

2. Two satellite images from Thit Tone Nar Gwa Son village tract, northern Maungdaw Township. Image 1, taken on 25 May 2017, shows intact houses and other village structures and farmland. Image 2, taken on 13 February 2018, shows burned Rohingya houses and other structures, terrain clearance and new construction. Information published by the Myanmar Government's Union Enterprise for Humanitarian Assistance, Resettlement and Development in Rakhine, dated 6 December 2017, lists the names of four ethnic Mro villages where 86 houses will be built "near Thittonena Gwa Sone village", in "Thittonena Gwa Sone" village tract. See: <http://rakhine.unionenterprise.org/latest-news-en/235-nearly-800-houses-under-construction-for-displaced-villagers-in-maungdaw>

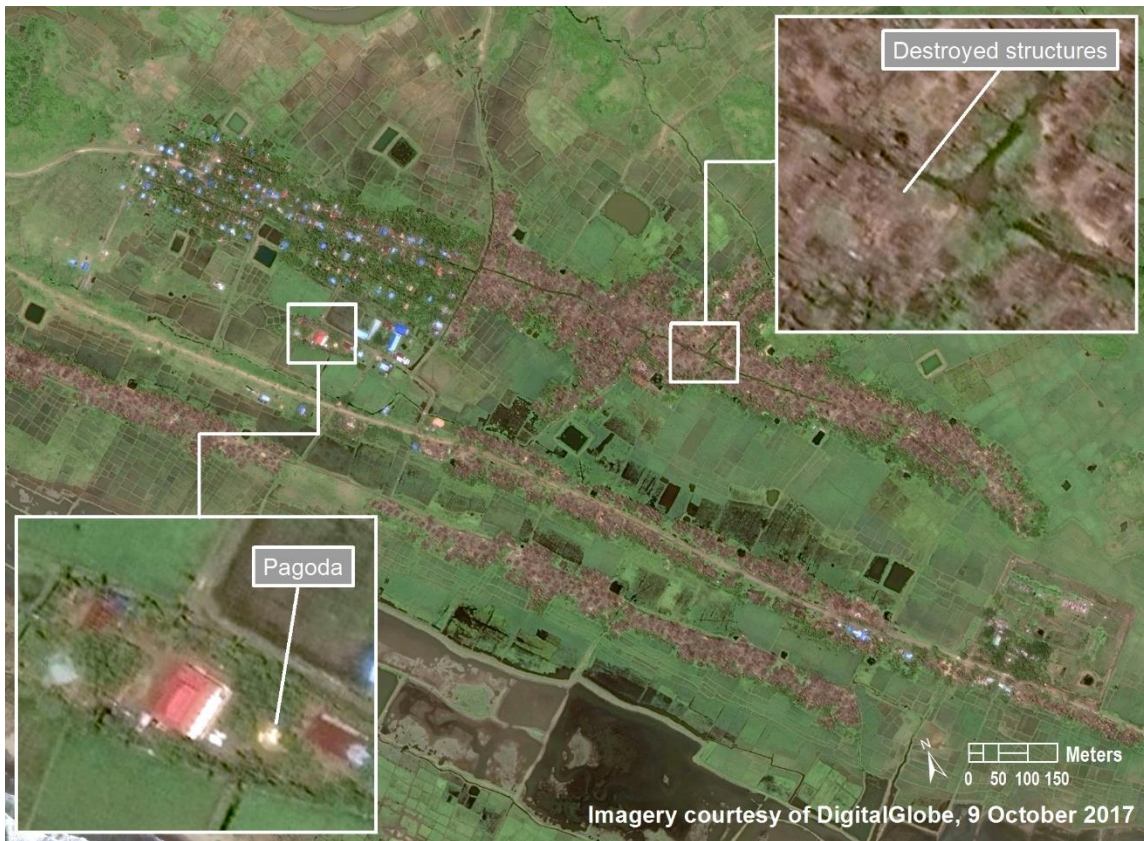
IMAGE 5: 9 October 2017

4. Two satellite images from Inn Din village tract, southern Maungdaw Township. Image 5, taken on 9 October 2017, shows the eastern and southern Rohingya settlements burned, while the non-Rohingya western settlement remains intact. A Buddhist pagoda is shown within the western settlement. Image 6, taken on 16 February 2018, shows visible terrain clearance and new construction, while the western settlement remains intact.
